Manhole Inspection Summary

Manhole # S17I1_008MH

Location Address: **2226 gable av**

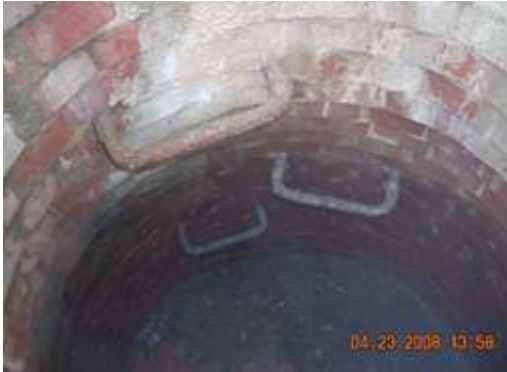
Defect 2

Steps Count: **3** Missing: **0** ☒ **Corroded**

corroded steps

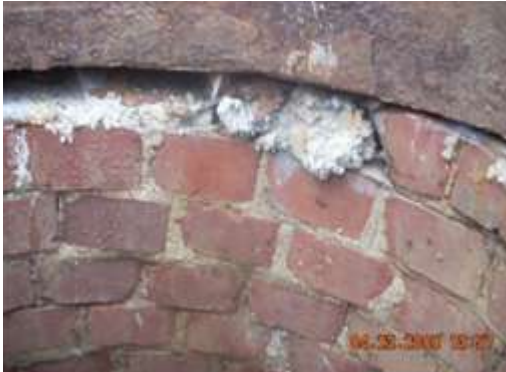
Defect 1

Chimney / Frame Adjustment ☒ Exists Material: **Brick and Concrete** ☐ Parged Height: **2** (in.)

Condition: ☐ Sound ☐ Cracked ☐ Root Intrusion ☐ Loose Brick ☒ **Deteriorated**

deteriorated chimney

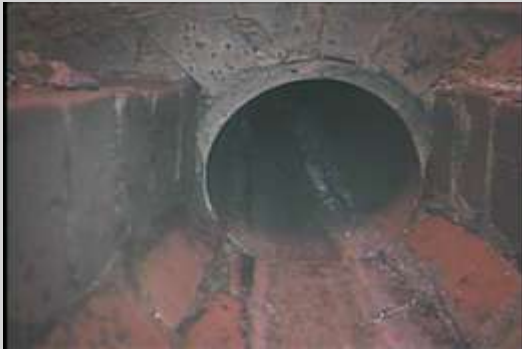
12 O'Clock Outflow

Pipe Height: **8.4** (in.) Rod and Bar (Angled)
Pipe Material: **Clay** ☐ Pipe Lined
Invert Depth: **7.30** (ft.) Flow Characteristics: **Fast**
Deposits: ☒ None ☐ Mud ☐ Sludge ☐ Debris ☐ Grease
Silt Depth: **0** (in.) Deposits Extent:
Infiltration: **None** Pipe Seal Cond: **Sound**

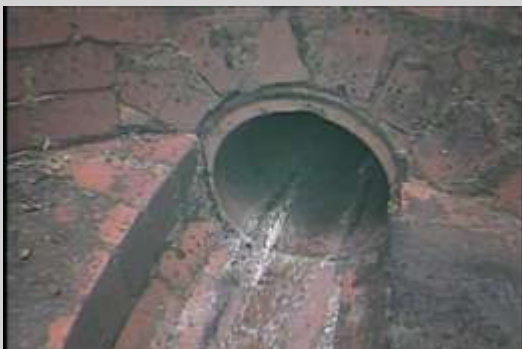
7 O'Clock Inflow

Pipe Height: **8.4** (in.) Rod and Bar (Angled)
Pipe Material: **Clay** ☐ Pipe Lined
Invert Depth: **6.60** (ft.) Flow Characteristics: **Fast**
Deposits: ☒ None ☐ Mud ☐ Sludge ☐ Debris ☐ Grease
Silt Depth: **0** (in.) Deposits Extent:
Infiltration: **None** Pipe Seal Cond: **Sound**
